tech talk

Getting Out Of A Bind

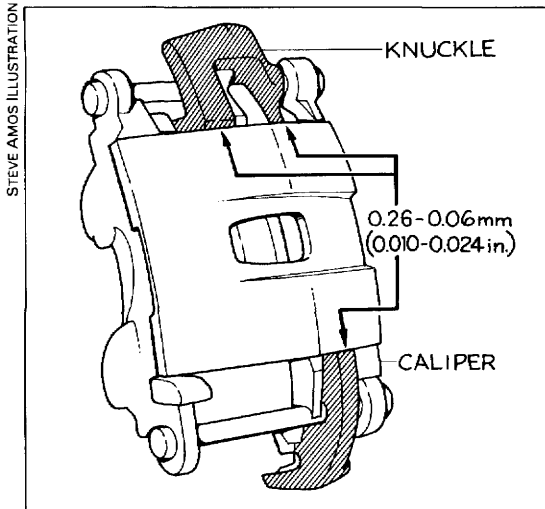
Heat generated during braking was causing each caliper to expand and bind in its steering-knuckle mounting. During braking, hydraulic pressure overcame the friction, and the pads moved against the rotor. However, upon release of brake pressure, only the caliper piston and inner pad would retract. The caliper remained stuck in its mounting, holding the outer pad firmly against the rotor, wearing the outer pad and continuing to generate heat, which continued to bind the caliper in its mounting.

When checking brake-caliper-to-steering-knuckle clearance on GM S/T-truck chassis, measure clearance at each caliper individually, then add all together to arrive at the total.

showed that the outer pads had worn completely through the pad material and were rubbing the metal backing plates on the rotors, thereby destroying the rotors. (The audible wear indicators are affixed to the inner pads, thus I had no audible indication of the rapid wear problem.) Checking the service manual, I found that there should be between 0.010- and 0.024-inch total clearance between the ends of each caliper and the steering knuckle. (Use a feeler gauge, measure clearances at each end of the caliper and add the clearances together.) Both calipers measured well below the minimum tolerance.

The fix was to disassemble the calipers from their mountings and to hand file (using a mill file) the steering knuckle to provide the proper clearance. Since this is a "cut and try" operation, it should be done in several small, careful steps. It's easy to remove too much material and wind up with brake calipers that "clunk" with each brake application.
